# **MONTSERRAT – A CASE STUDY IN THE APPLICATION OF MULTIPLE METHODS TO MEET A POST DISASTER HOUSING SHORTAGE**

**Andrew P. Fox<sup>\*</sup>**

**Centre for Disaster Management, Coventry University, UK**

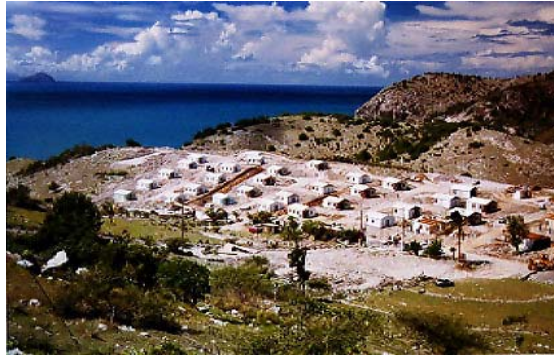
Davy Hill by permission: Doug Darby

HMG priorities at this time were to reduce population numbers in the temporary shelters as speedily as possible. With this in mind, B&R procured an American prefabricated housing unit and was able to co-ordinate the majority of the logistical complexities of design, procurement, shipping and construction of the housing units complete with infrastructure provisions – roads, electrical reticulation, water supply, drainage and sanitation within a three month period.

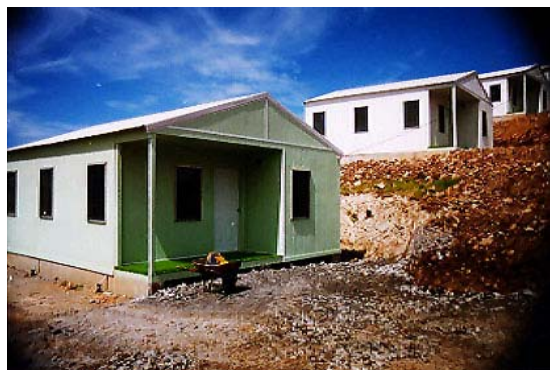
IBS houses by permission: Doug Darby

The housing units were of a timber frame construction with fibre cement board/polystyrene/medium density fibreboard (MDF) sandwich wall panels, timber roof trusses and corrugated steel roof sheets. Floors were plywood with vinyl covering (George Pinder, International Building Systems, IBS).

The housing units were sited on individual plots and comprised 2 bedrooms, a shower room and a combined kitchen/dining/living area and a small veranda.

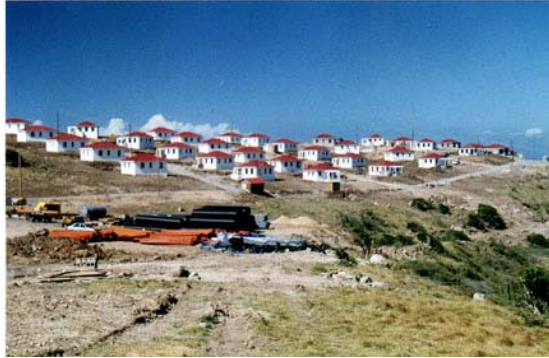
Lookout Yard by permission: Doug Darby

Alongside the 50 prefabricated units, B&R were commissioned to construct 100 permanent houses using masonry construction.

The units were to be built in 2 phases of 50 houses each. For this project B&R worked closely with local architects and GoM planning officials.

The first phase of housing consisted of 3-bedroom villa style houses with dual 110/220 voltage, fitted kitchens and wardrobes, beam and rafter ceilings, corrugated alloy roof sheeting, verandas and fully tiled floors.

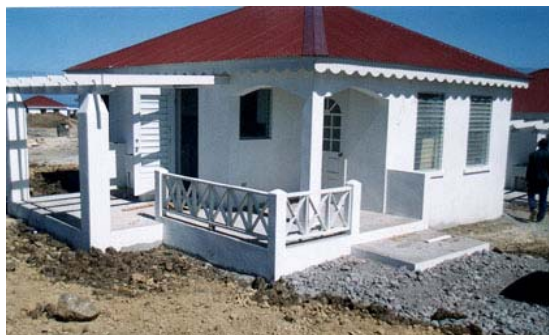
Lookout Yard by permission: Doug Darby

The second phase of development followed similar specifications but involved a mix of 2, 3 and 4 bed units in semidetached or individual blocks depending on local topography.

Variations were introduced to the second phase units in the form of sash windows, which performed better than louvered windows in the exposed conditions of the development site.

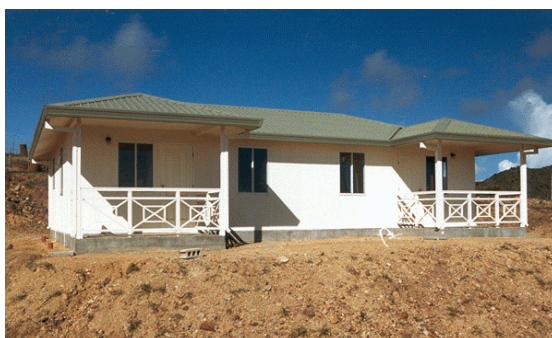
Force10 house by permission: Force10

The housing system was a modular steel framed system, used in the Caribbean region but sourced from Australia (Force 10). The system comprised fibre cement board and polyurethane sandwiched wall panels, a steel trussed roof with corrugated alloy roof sheeting and integral rainwater guttering system.

The units procured were 2, 3 and 4 bedroom styles in semidetached and individual blocks. The internal finishes matched the specifications of the masonry units with the exception that single 220v electrical systems were installed.

Approximately 50% of the units were built on concrete raft foundations/floor slabs. Where the terrain was too steep to create a level pad, the units had suspended steel framed floors with dense fibre cement floor boarding. The suspended floors sat on braced steel columns set into concrete strip footings.
